Air force surveys in geophysics

No. 135

Evaluation of arctic ice-free land sites
Kronprins Christian Land and Peary Land,
North Greenland 1960

William E. Davies
Daniel B. Krinsley

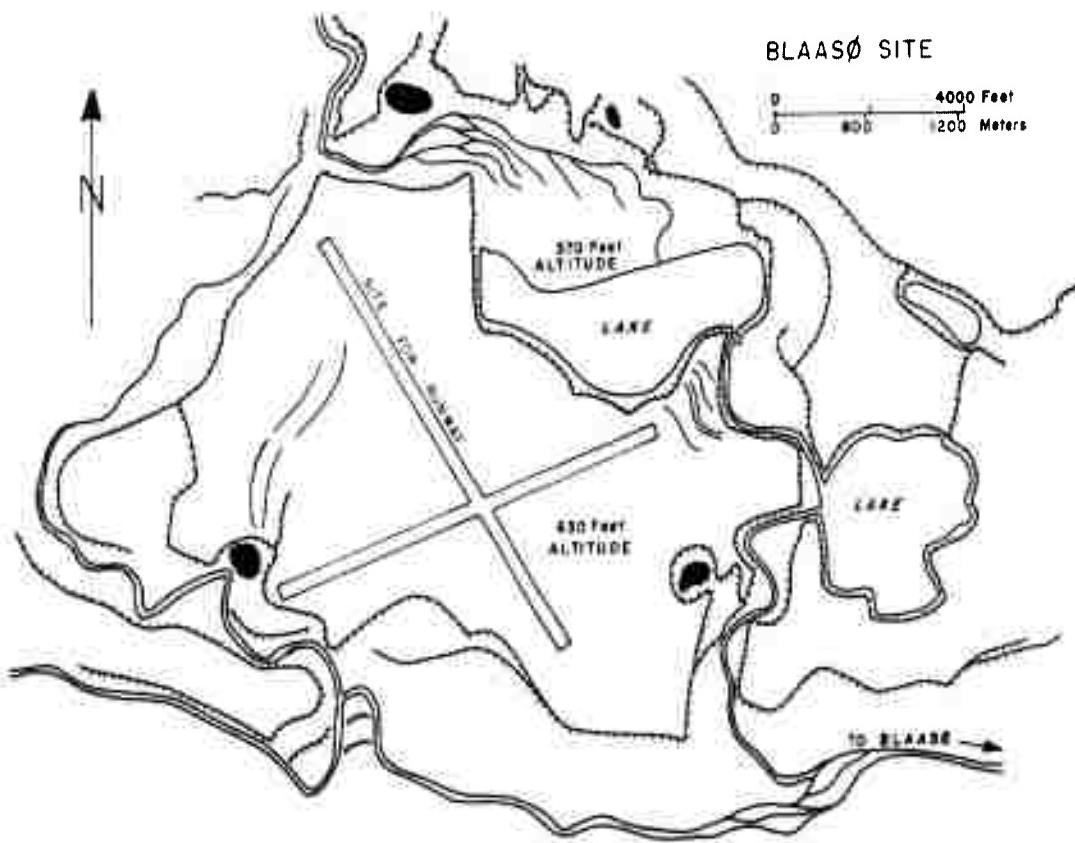
Figure 7. Map of Blaasø site.

Dimensions and orientation -- There are two possible runway orientations. A 9000-ft (2743-m) runway is oriented N33°W, and a 8400-ft (2560-m) runway is oriented N70°E (Fig. 7).

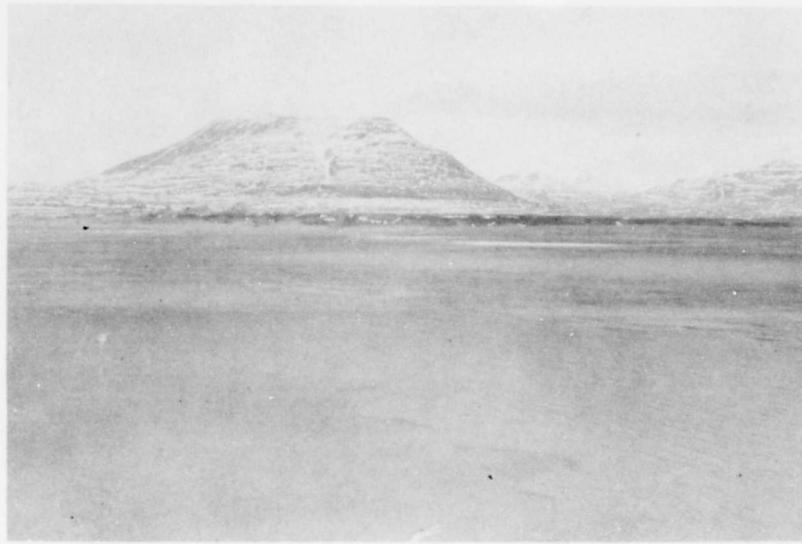
Figure 9. Kap Renaissance site, view west over Sjaellandssletten. 2 July 1960.

Landform -- The site is near the mouth of a broad valley (Zig-Zag Dal). The valley floor is 1.8 miles (3 km) wide and 3.6 miles (6 km) long. It is at an altitude of 75 to 150 ft (22 to 45 m). The site is bordered on the north and west by a dissected plateau 2400 ft (730 m) high (Fig. 9). The front of the plateau is a scarp in the upper half and a steep talus slope below. To the south and east the site is bounded by low rounded hills rising to a dissected plateau 3000 ft (915 m) high, 3 miles (5 km) south of the site.

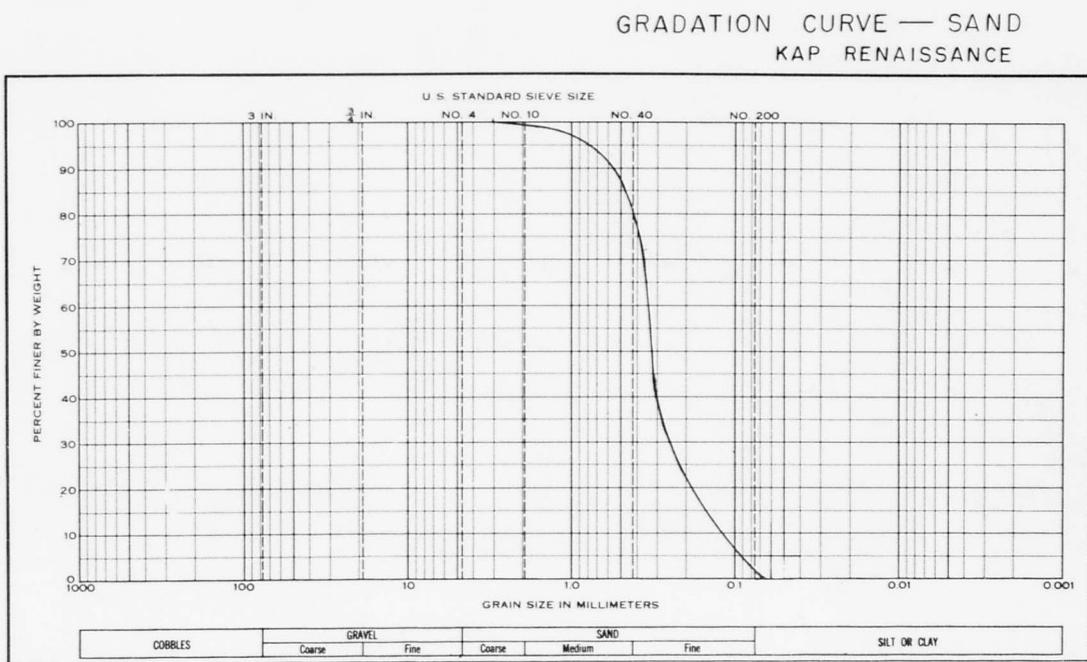
Figure 10. Kap Renaissance site, gradation curve, sand.

Soil and drainage -- The surface soil is a well-drained, poorly graded, coarse sand (Fig. 10). The upper 6 inches (15 cm) is dry and loose; below this it is damp but weak. At 20 inches (50 cm) the CBR is less than 3. The sand is about 3 to 8 ft (1 to 2 m) thick resting on clay-silt which is exposed in valleys and flats bordering the sand area.

Engineering aspects -- The site would require no grading. Stabilization and strengthening of the sand surface would be necessary to prevent excessive rutting. In addition, stabilization is necessary to control

drifting sand which is common at the site. Silty clay for use as a binder is abundant adjacent to the sand flat.

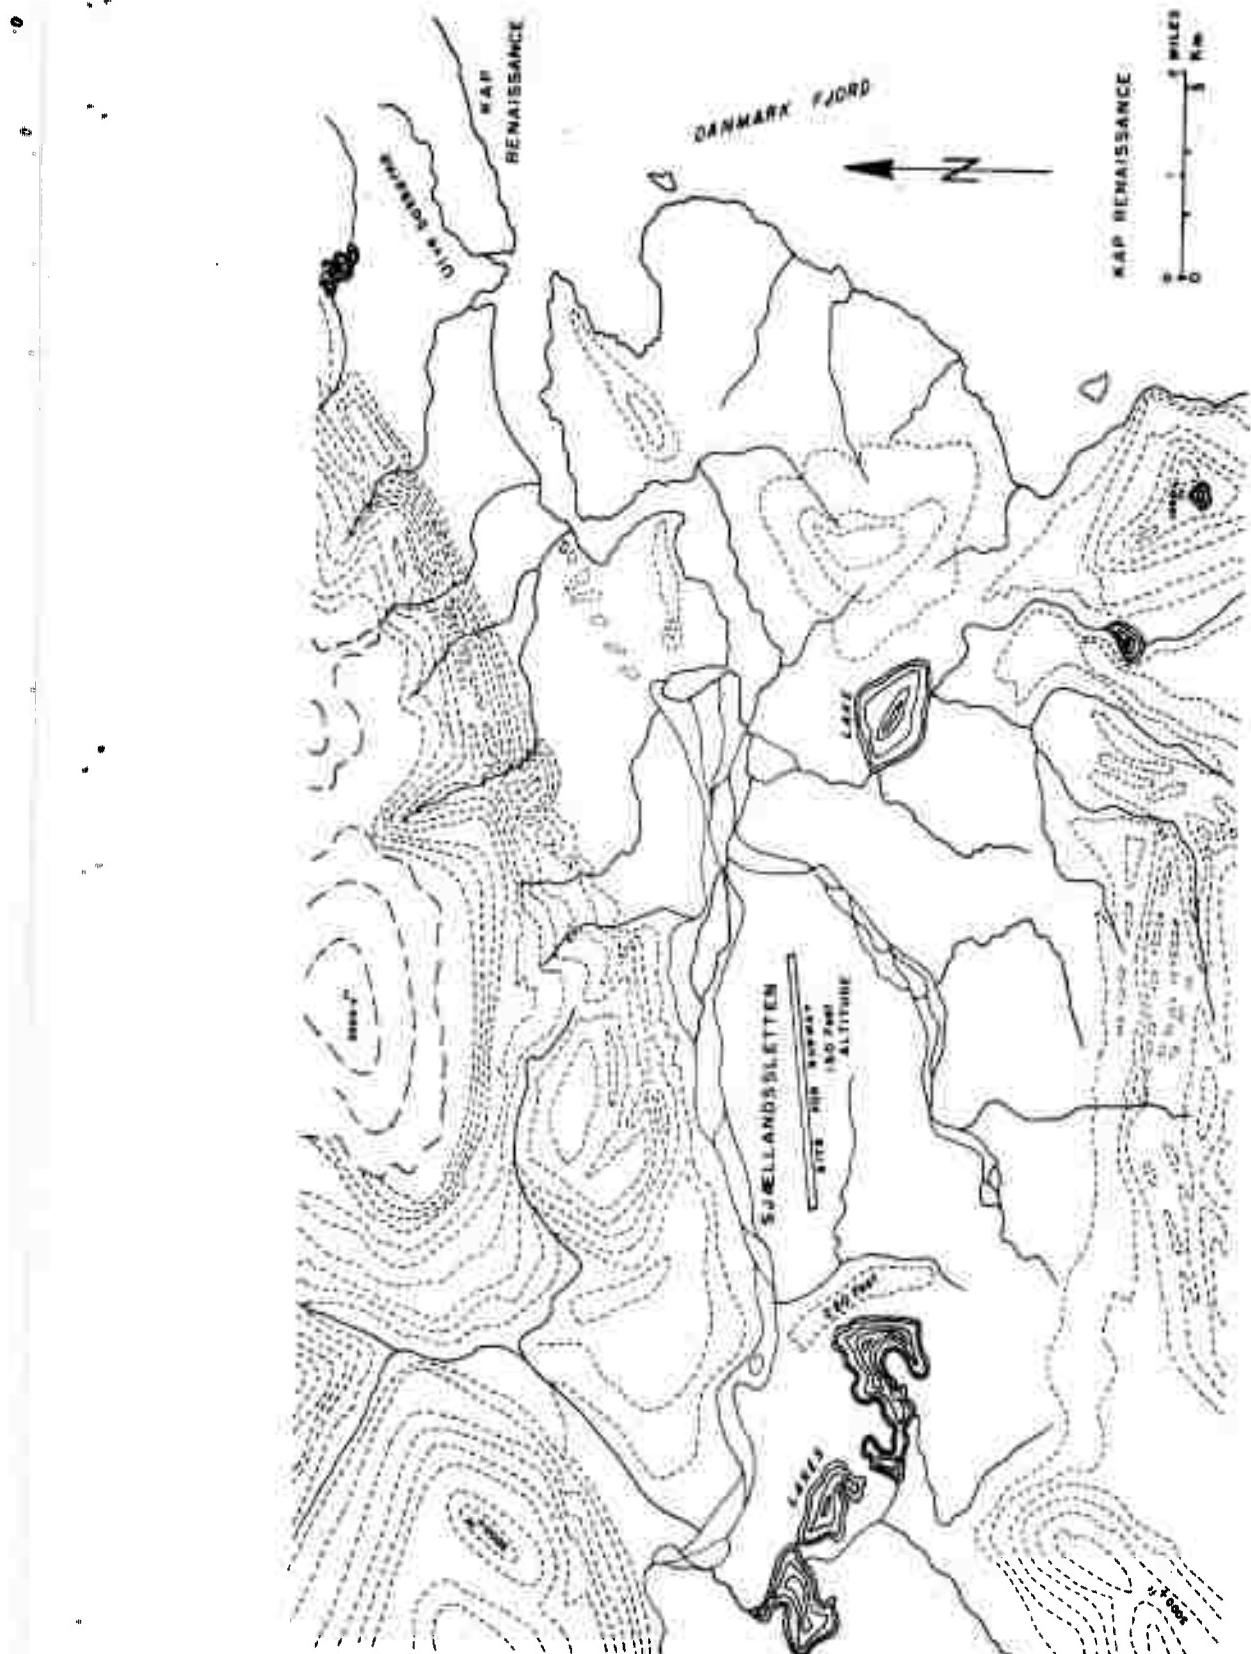
Figure 11. Map of Kap Renaissance site.

Dimensions and orientation -- The best orientation for a runway is east-west. A length of 12,750 ft (3900 m) with minimum width of 600 ft (182 m) can be utilized without grading (Fig. 11).

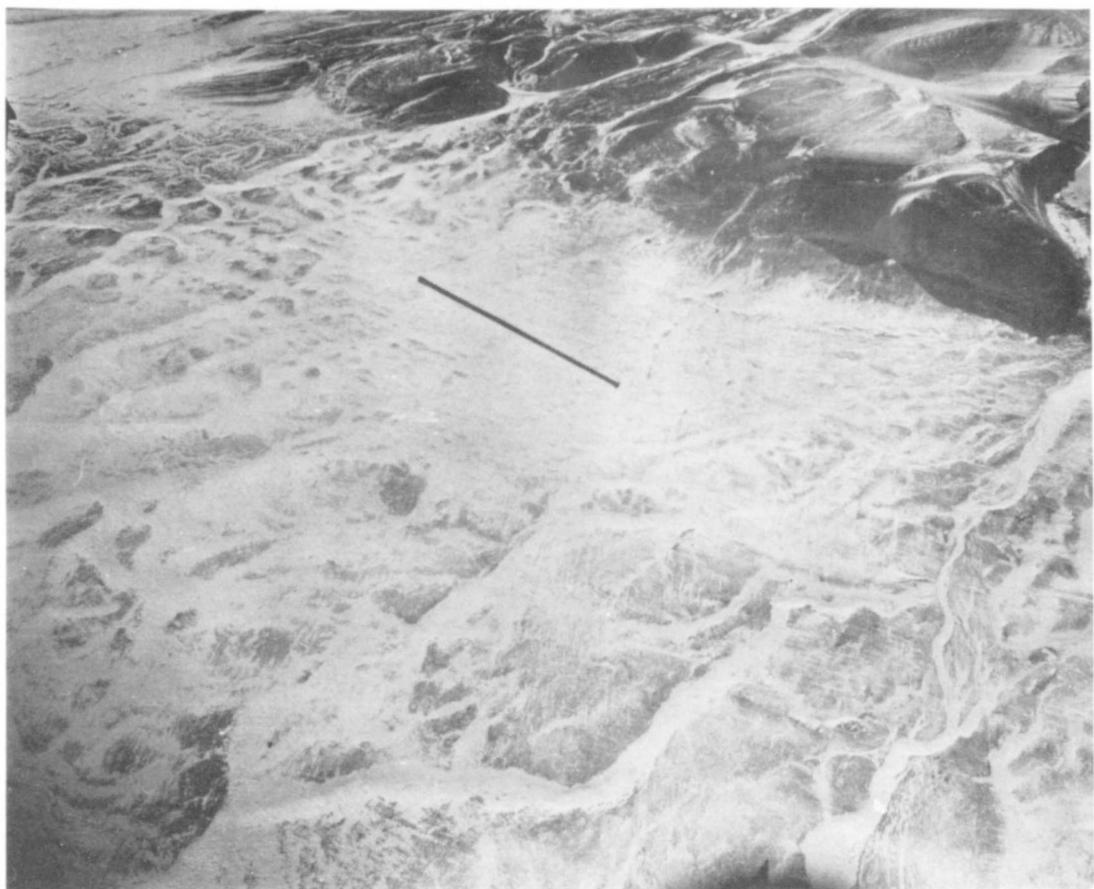
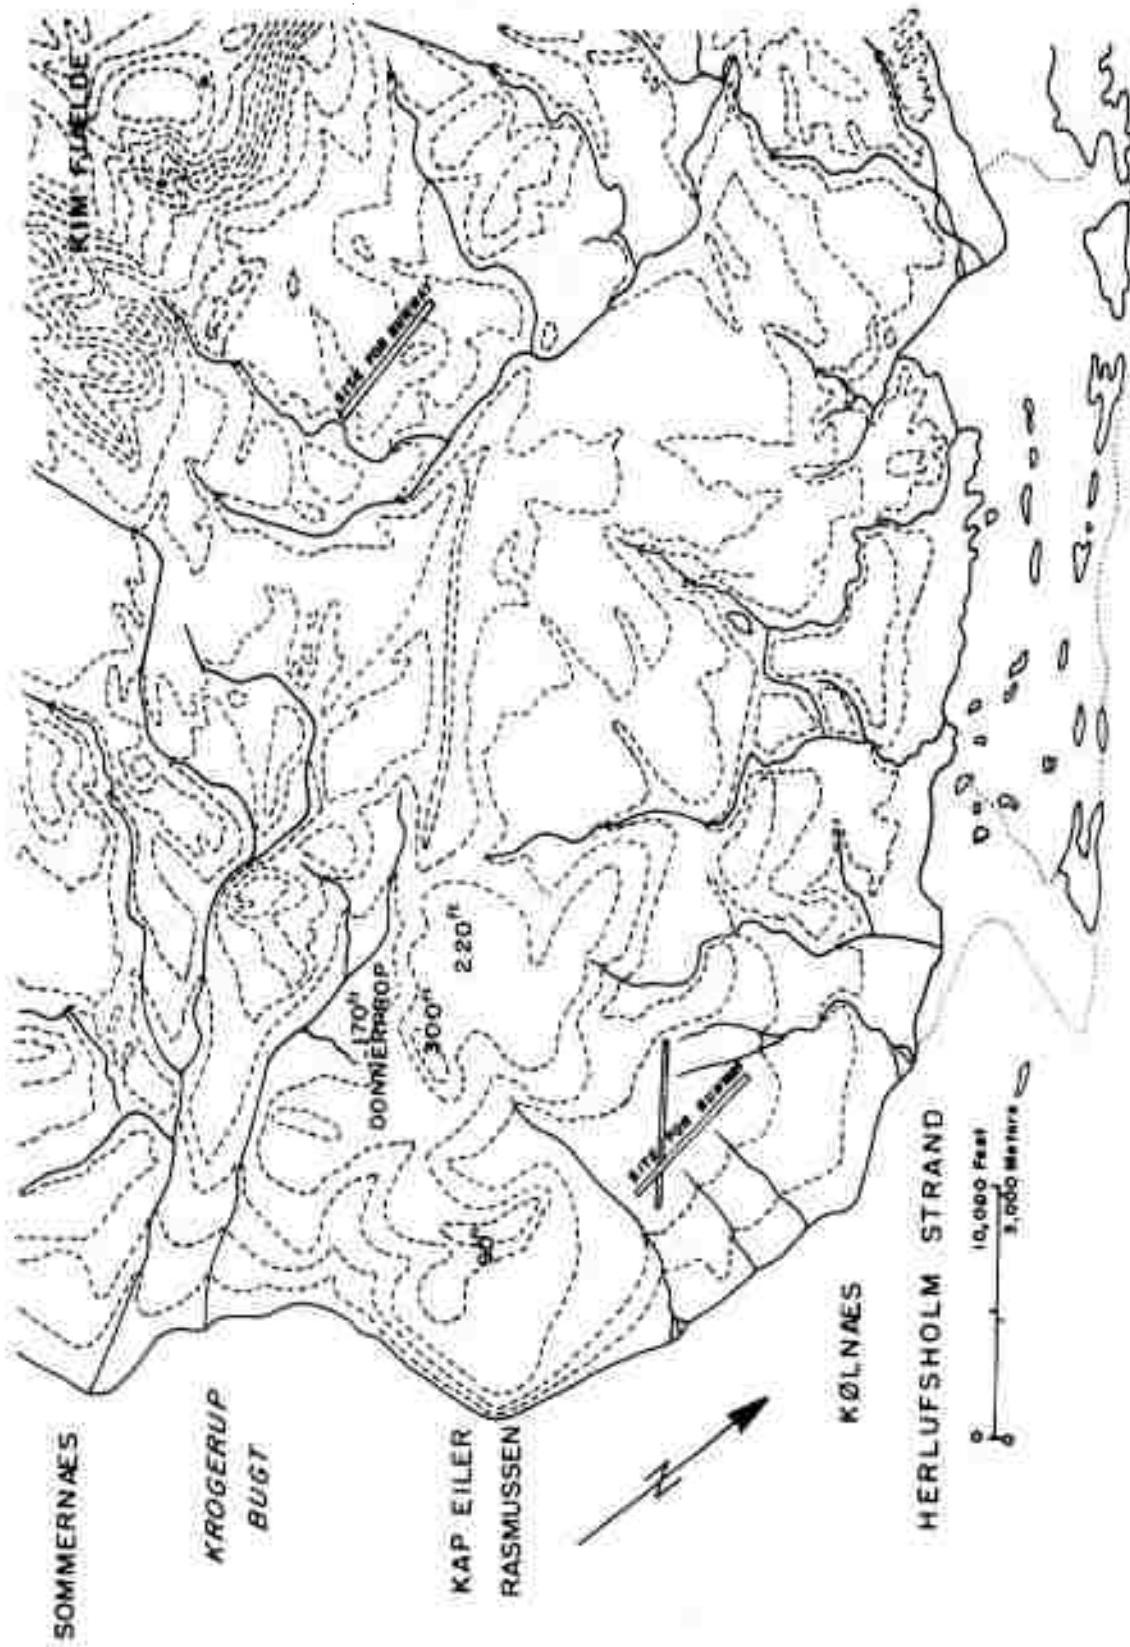
Figure 13. Map of sites at Herlufsholm Strand.

Landform -- The sites are on a coastal plain 6 to 8 miles (10 to 13 km) wide that extends 20 miles (32 km) northeast from Independence Fjord. The plain slopes gently from the Arctic Ocean southwards to the foot of the mountains where it is about 300 ft (91 m) high. Prominent terraces and moraines as much as 330 ft (100 m) in altitude occur over most of the strand. The site near Kølnaes is on a beach about 3 ft (1 m) above sea level. The other site is on a terrace at the base of the mountains.

Soil and drainage -- (a) Kølnaes site. The soil is of angular cobble and pebble gravel in a matrix of coarse sand. At the time of visit (4 July) the soil was frozen at a depth of 6 inches (15 cm). Soil was wet and soft in places.

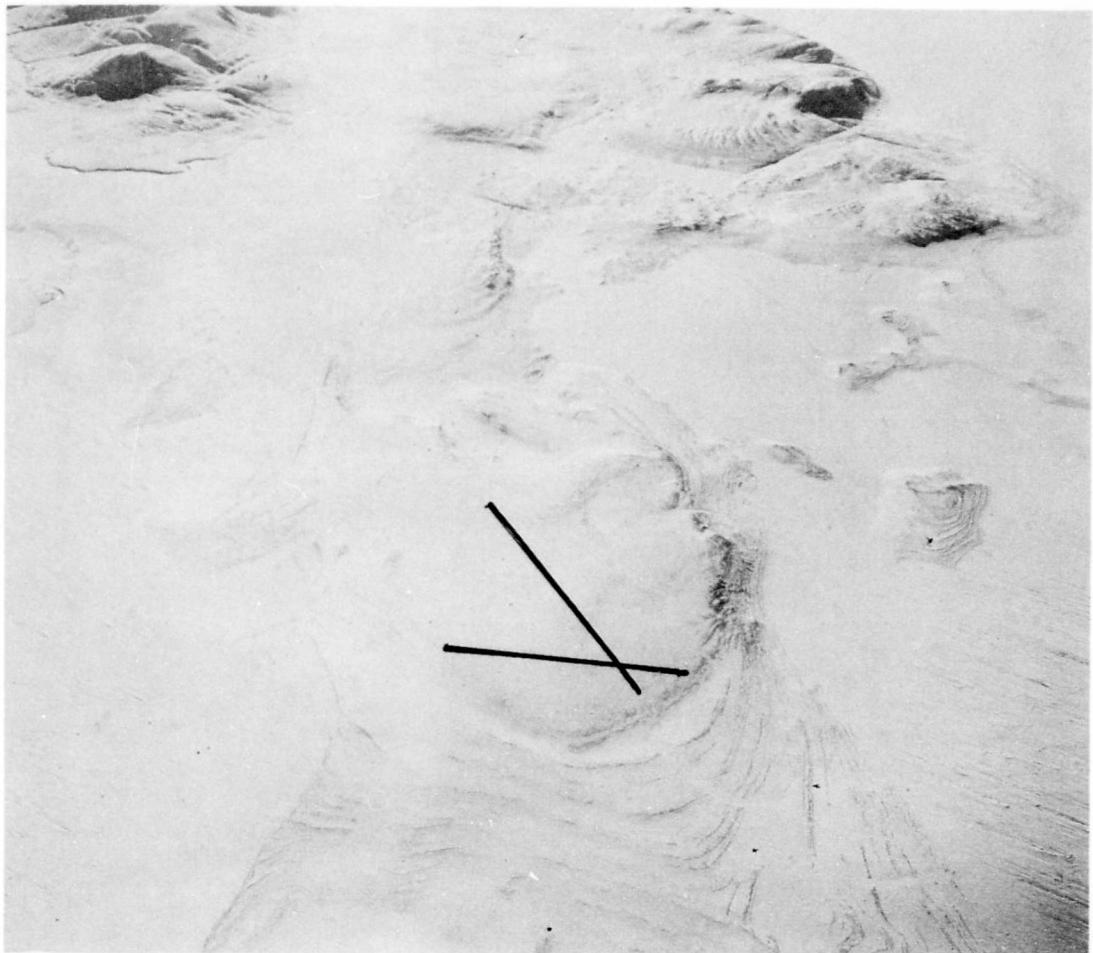
Figure 14. Kap Wyckoff, view west.

Location -- At Kap Wyckoff, Peary Land. $82^{\circ}54'N \times 24^{\circ}00'00''W$ (Fig. 14).

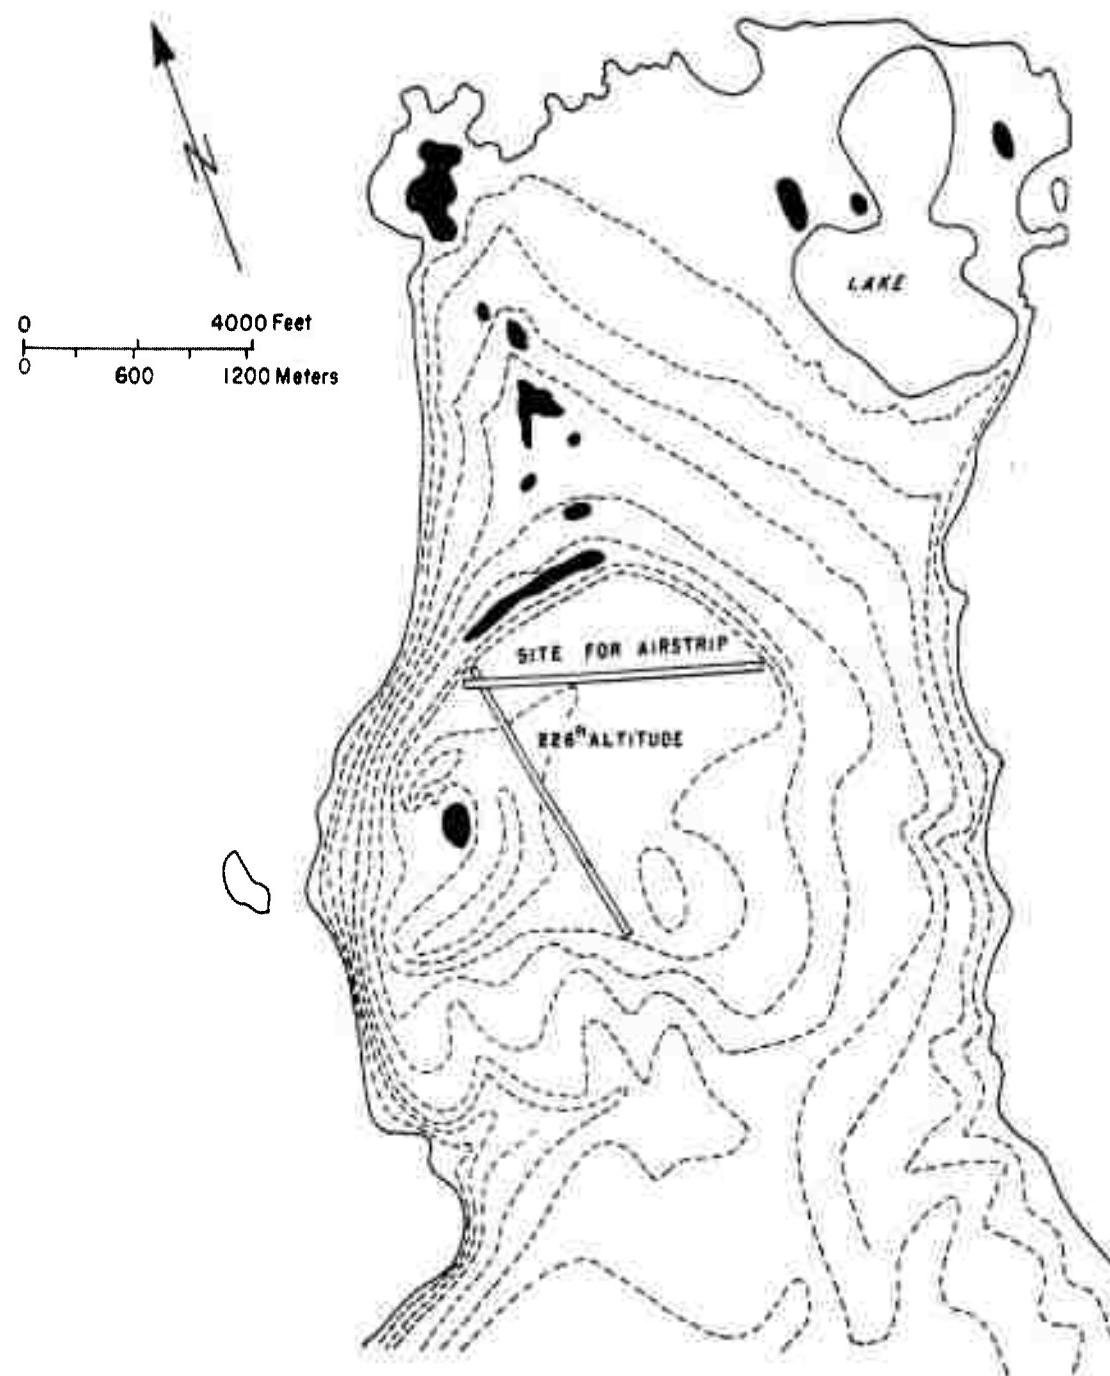
Figure 15. Map of Kap Wyckoff site.

Dimensions and orientation -- Two runways are possible, one oriented N10° W with 5100 ft (1554 m) length; the other oriented N80° W with 5400 ft (1649 m) length (Fig. 15).

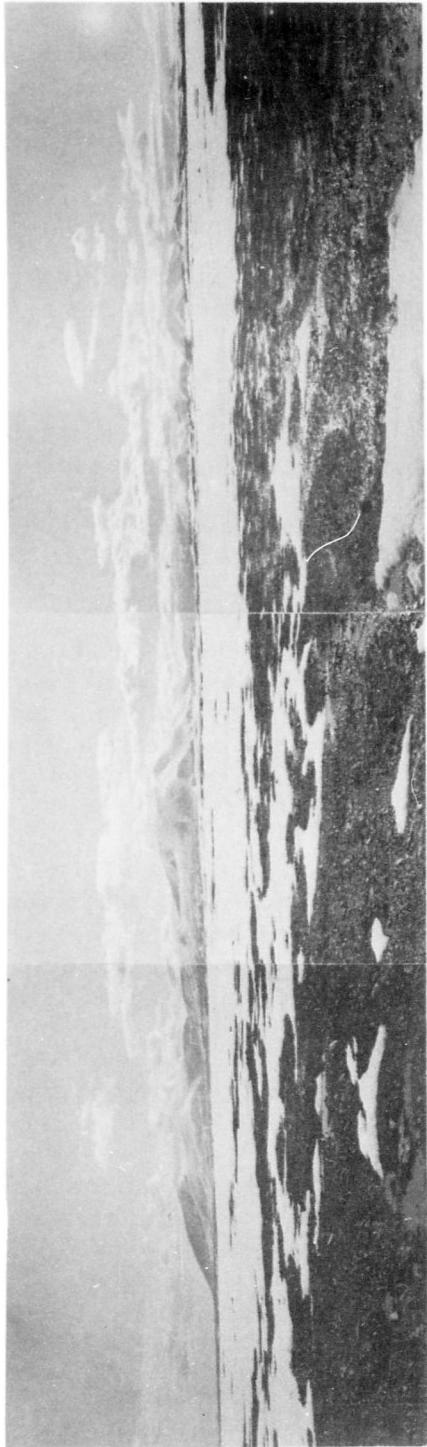
Figure 17. Skagen site, view southwest, 5 July 1960.

Landform -- Skagen is a rounded promontory, 4500 ft (1371 m) wide and 7500 ft (2286 m) long, extending eastwards into the Arctic Ocean. The summit, at an altitude of 80 ft (24 m), is flat (Fig. 17) while the sides of the promontory are cut by two prominent raised beaches at 40 ft (12 m) and 55 ft (17 m). The beaches are in the form of benches 30 to 200 ft (9 to 60 m) wide.

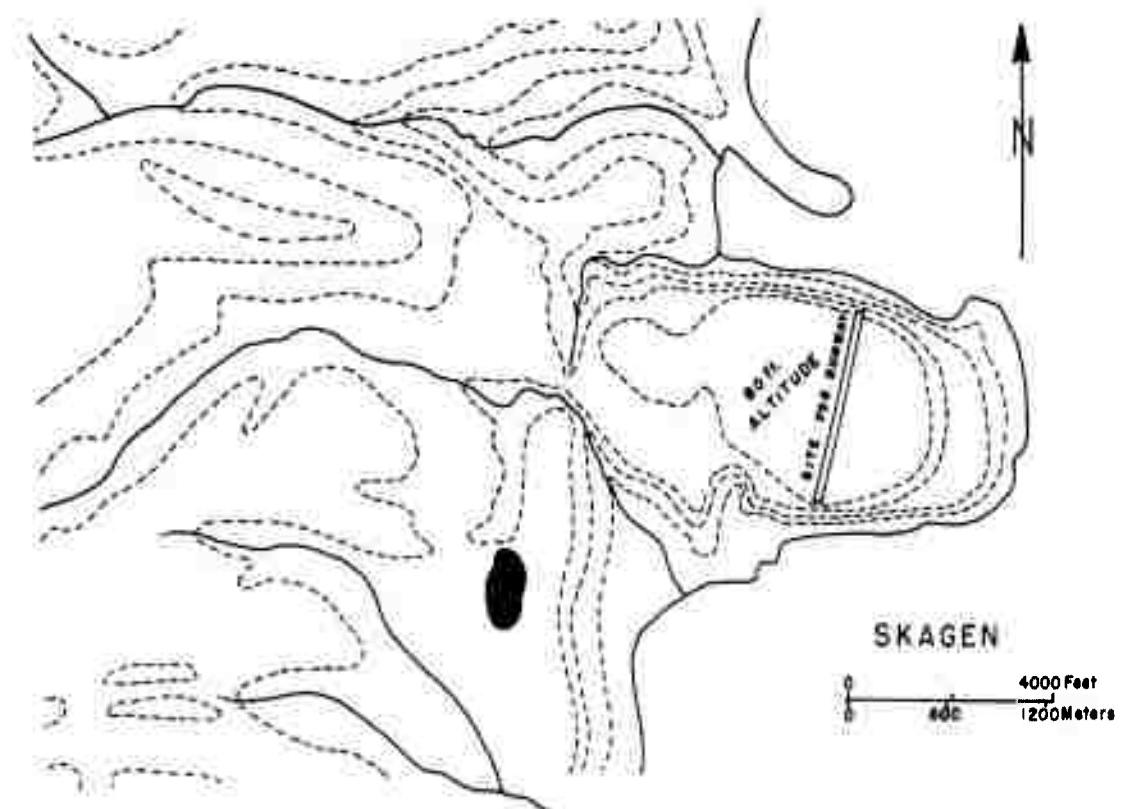
Figure 18. Map of Skagen site.

Engineering aspects -- Grading of 2000 cubic yards (1530 cubic meters) of material will be necessary to remove frost mounds and depressions. Mounds are about 12 inches (30 cm) high and 10 ft (3 m) in diameter. Occasional depressions are 3 ft (1 m) wide, 10 to 20 ft (3 to 6 m) long, and 12 inches (30 cm) deep.

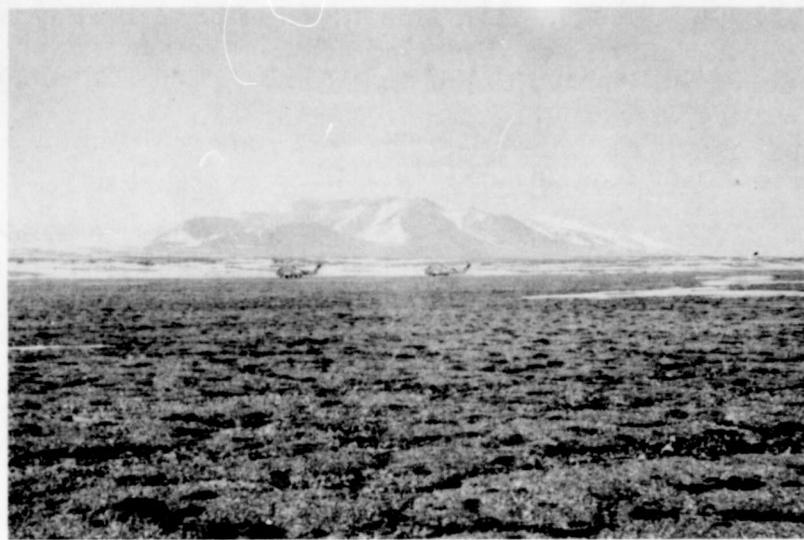
Figure 19. Kap Ole Chiewitz site, view WNW,
6 July 1960.

Landform -- The site is on a broad river terrace about 7 ft (2 m) above the Frihed-Radet Elv. The terrace is 3600 ft (1100 m) long northwest-southeast and 2000 ft (610 m) wide northeast-southwest. It is 155 ft (47 m) above sea level. On the northeast and east the site is bounded by morainal ridges rising to 215 ft (65 m); to the northwest the terrace grades into the wide outwash plain that forms the north side of Peary Land. The surface of the terrace is locally pitted with shallow frost depressions as much as 24 inches (60 cm) in diameter and 6 inches (15 cm) in depth (Fig. 19).

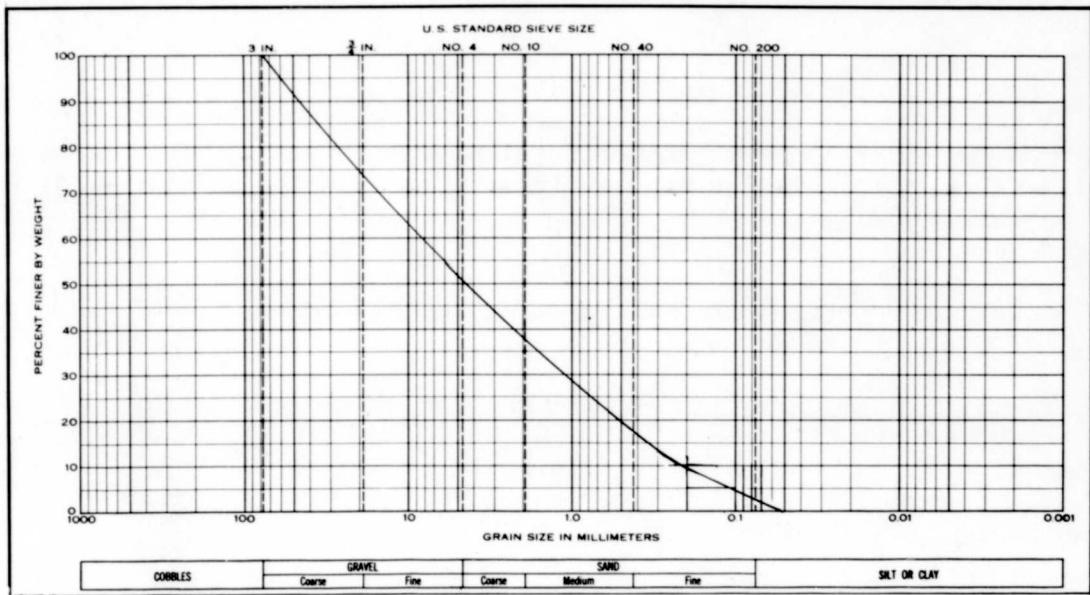
Figure 20. Kap Ole Chiewitz site, gradation curve, gravel.

Soil and drainage -- The soil along the site for a runway is densely-packed gravel in a matrix of silty sand. The gravel is composed of pebbles as much as 2 inches (5 cm) in size (Fig. 20). Drainage is good.

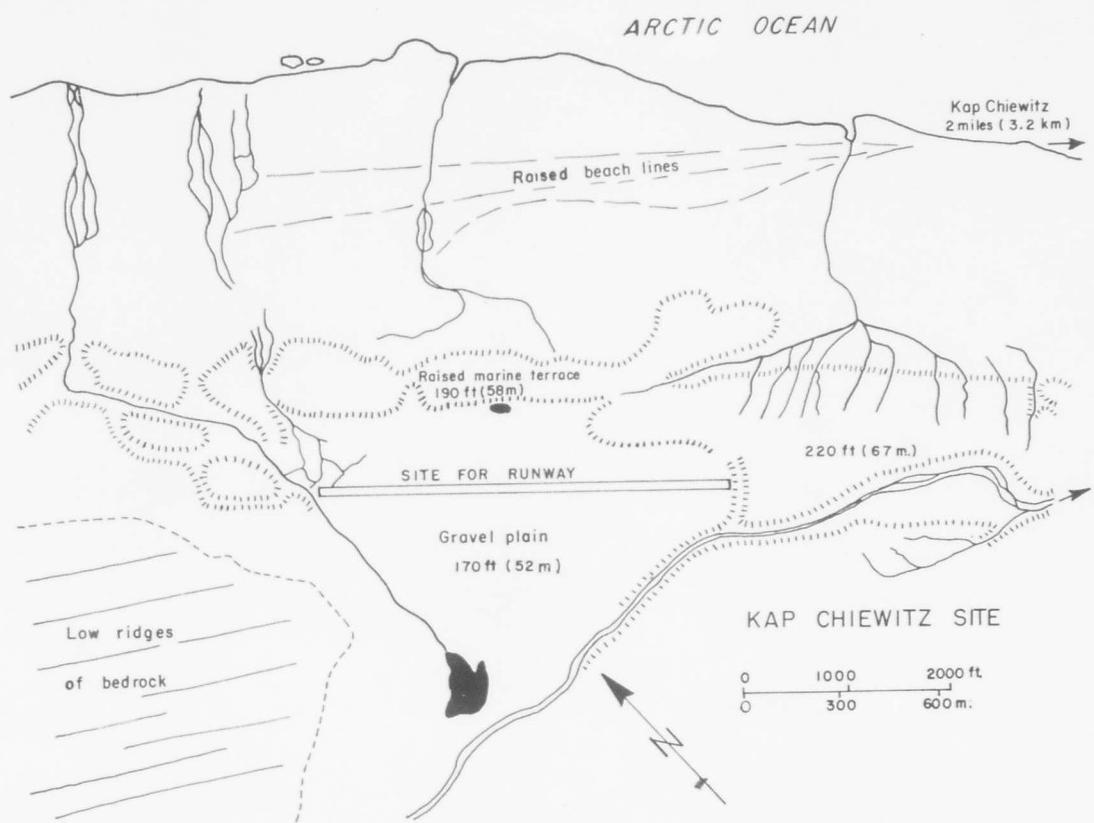
Figure 21. Map of Kap Ole Chiewitz site.

Dimensions and orientation -- The best runway orientation is N60°W, with a length of 3600 ft (1100 m) (Fig. 21).

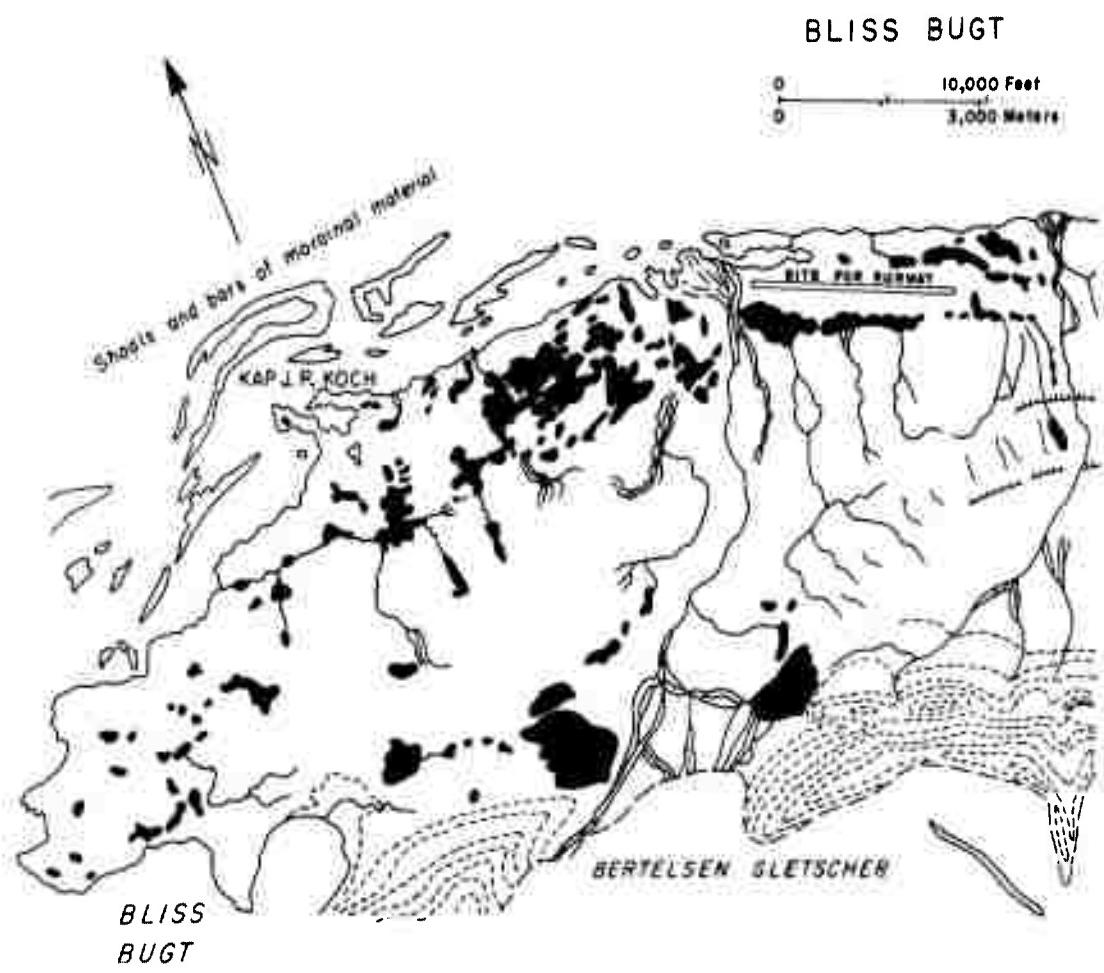
Figure 23. Map of Bliss Bugt site.

Location -- On the northeast corner of Bliss Bugt, 2 miles (3 km) east of Kap J. P. Koch (Figs. 22 and 23).

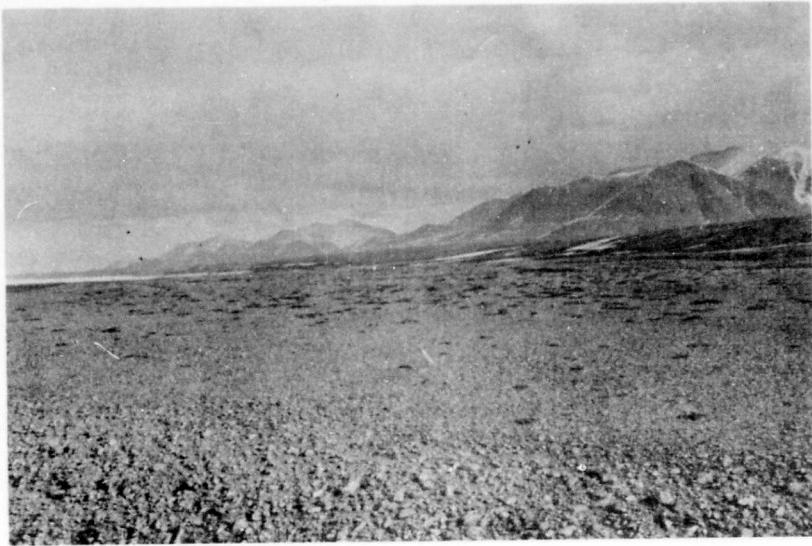
Figure 24. Kap Morris Jesup site, view south-east, 6 July 1960.

Landform -- Kap Morris Jesup is on a broad fan-shaped delta about 2400 ft (731 m) north-south and 12,000 ft (3657 m) east-west. On the south side of the delta are a series of raised beaches cut into two parts by the north-flowing stream that enters the Arctic Ocean at Kap Morris Jesup (Fig. 24).

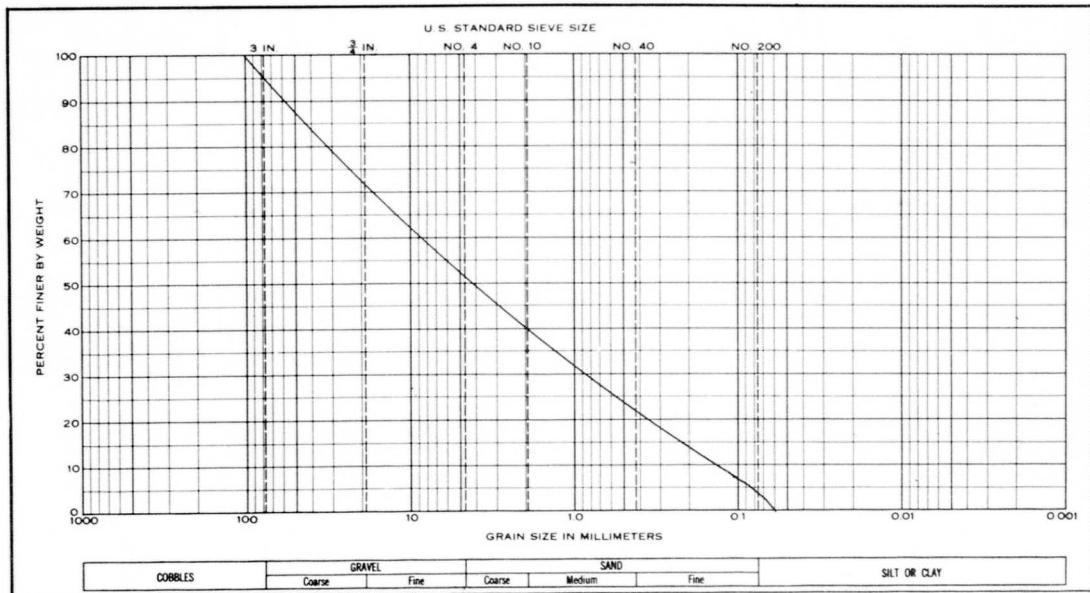
Figure 25. Kap Morris Jesup site, gradation curve, gravel.

Soil and drainage -- At the site the soil is compact gravel made up of rounded pebbles and cobbles, maximum diameter 3 inches (7.5 cm). Matrix is coarse sand (Fig. 25). Drainage is good.

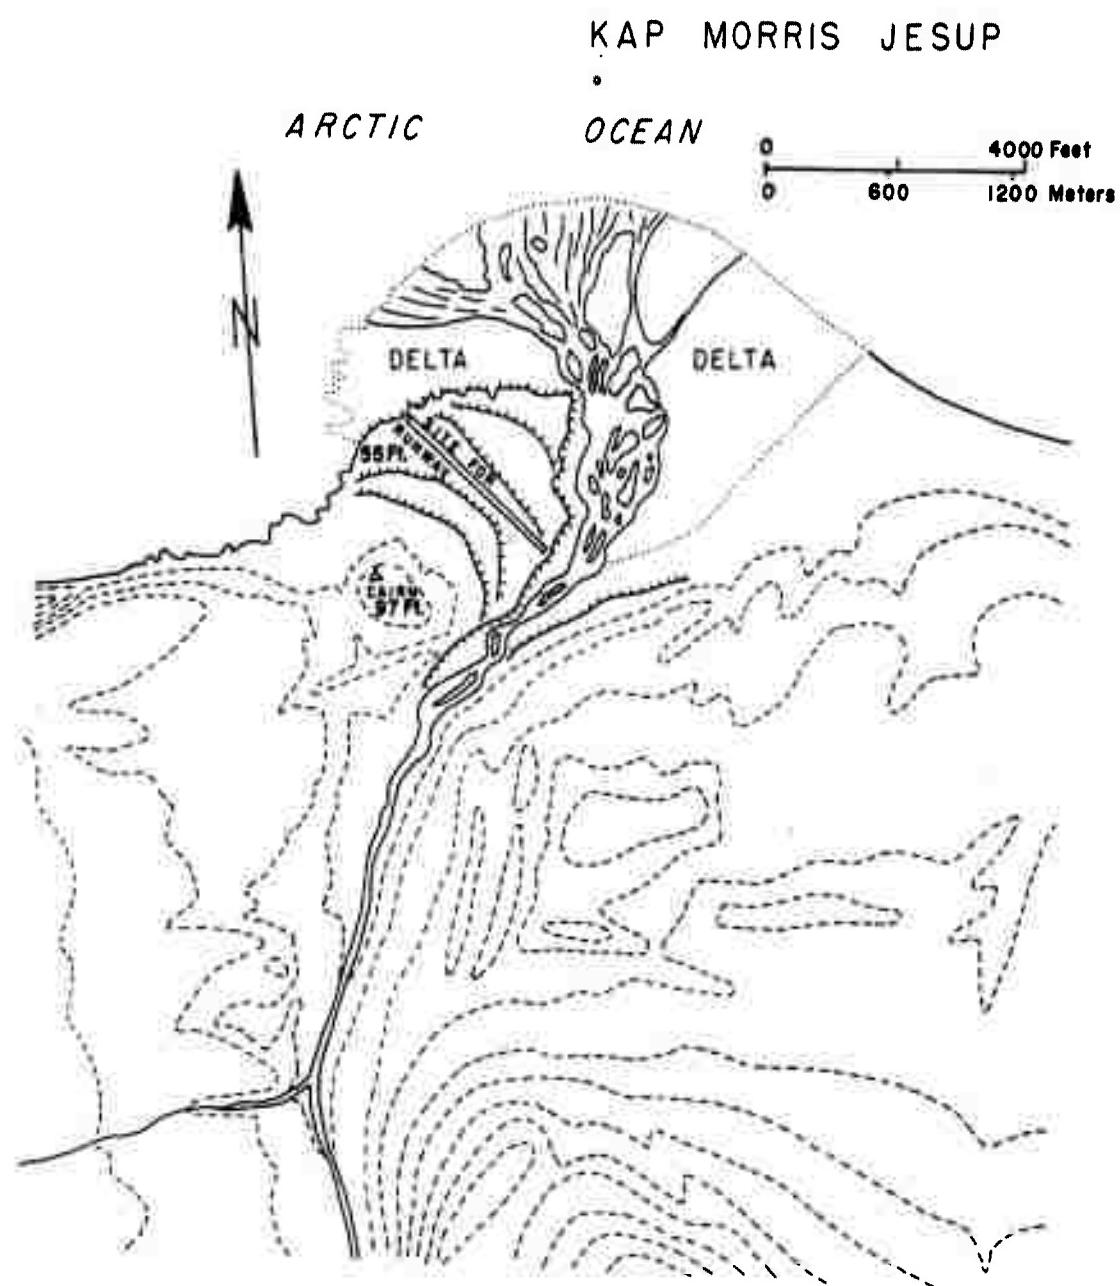
Figure 26. Map of Kap Morris Jesup site.

Dimensions and orientation -- On the 80-ft (24-m) terrace there is a site for a runway 2800 ft (853 m) long, oriented N45°W (Fig. 26).

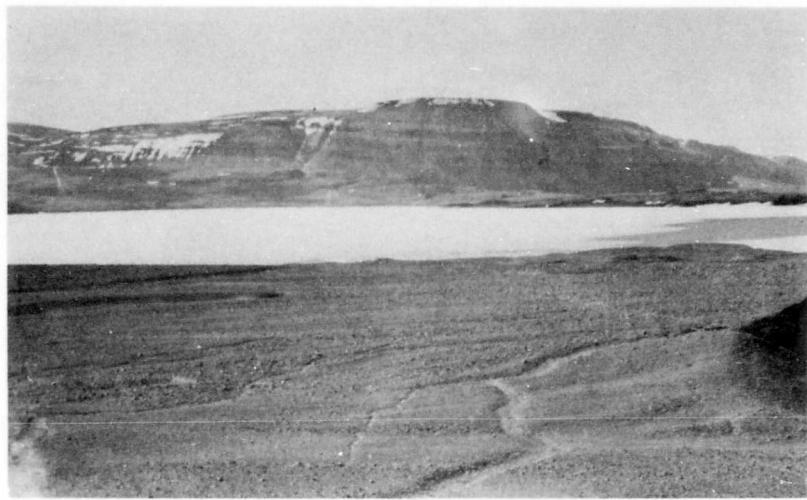
Figure 28. View west at west end of Slusen site,
10 July 1960.

Landform -- At Slusen the river channel is bounded on the north and south by terraces. The upper broad terrace is 23 ft (7 m) above the level of Midsommersø (Fig. 28). It is 4500 ft (1371 m) long east-west and about 3000 ft (914 m) wide. To the north this terrace grades into a kame terrace that is 90 ft (27 m) above the level of the lake. This kame terrace is 750 ft (228 m) wide and ends at the base of a third terrace which is 900 ft (274 m) wide and ends on the north at an outcrop of diabase. The terrace surfaces have numerous frost mounds and polygon trenches with relief as much as 3 ft (1 m) in height.

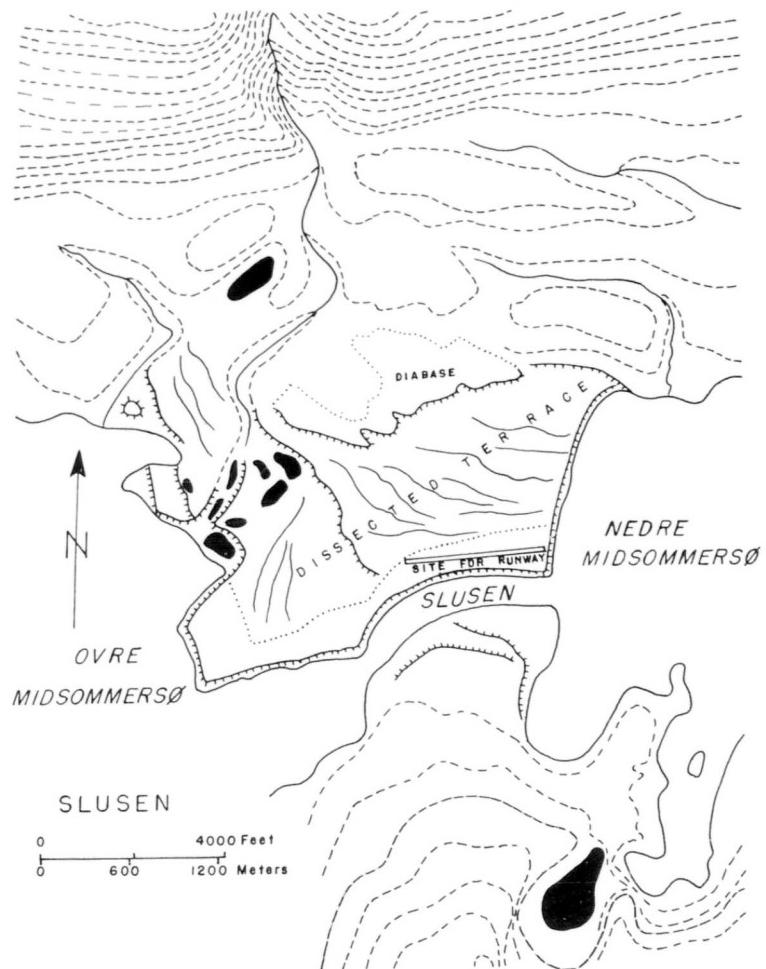
Figure 29. Map of Slusen site.

Dimensions and orientation -- The best site for an airstrip is on the 23-ft (7-m) terrace 30 to 1600 ft (10 to 183 m) from Slusen, oriented in an east-west direction. A runway 3000 ft (914 m) long could be made with minimum grading; and with moderate grading a runway 4500 ft (1371 m) long could be made (Fig. 29).

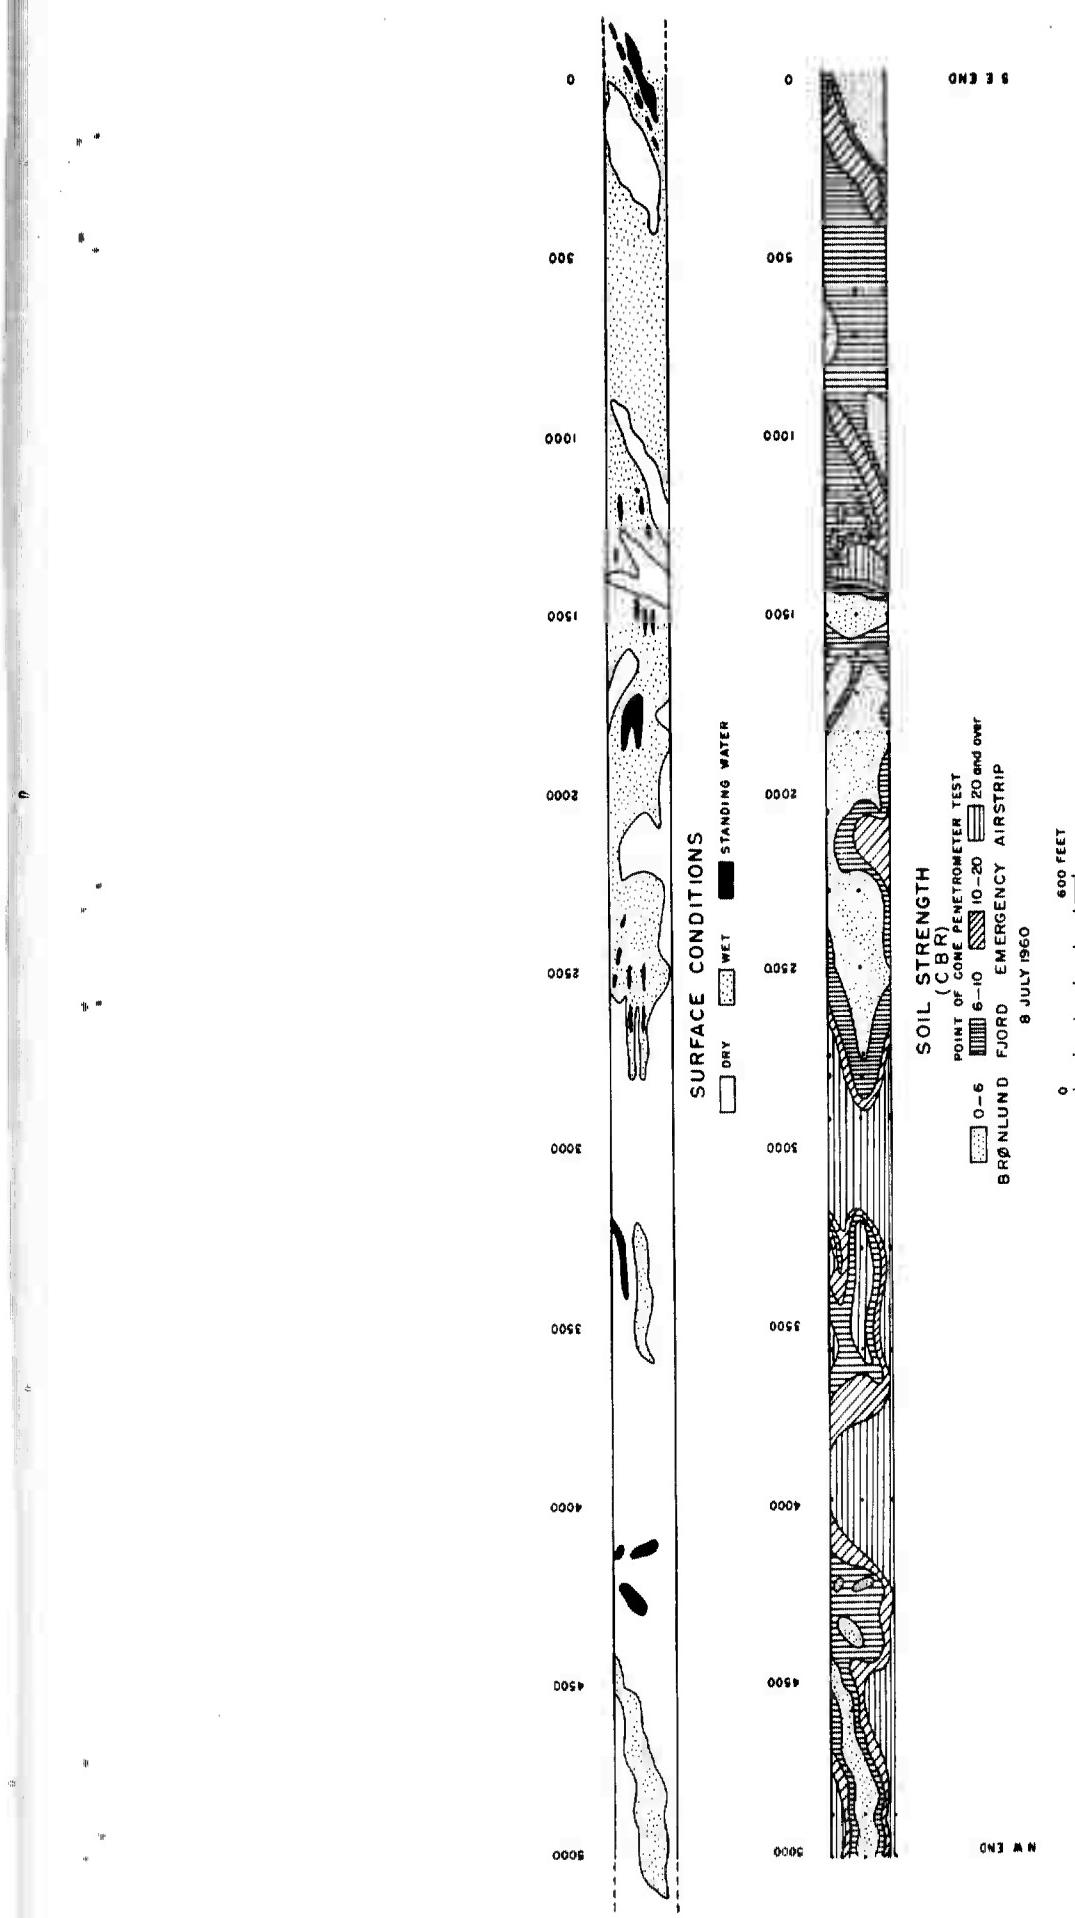
Figure 32. Plan of runway at Brønlund Fjord showing strength of soil and surface conditions.

Condition of runway -- The runway at Brønlund Fjord is on the floor of a former lagoon. The soil is a hard packed clay-silt. The runway is 5000 ft (1524 m) long, oriented N35°W. On 8 July 1960 the west half of the runway was dry and strong with soil strengths as high as 25 (CBR) 1/. The east half had several wet areas where drainage from

the south crossed the site and in places where wheel ruts were made by the test aircraft (Figs. 30 and 31). In the wet areas, soil strength was very low (CBR 0 to 6). Detailed CBR readings were made along the runway at intervals of about 500 ft (152 m) (Fig. 32 and Table 2).

Conclusions -- The east half of the runway at Brønlund Fjord is not safe for use in its present condition from early June to mid-July. Shallow ditches parallel to the runway to divert drainage from the hills to the south would probably make the runway suitable for 12-month capability except for a period of a week or two in early June.
